AVIATION INVESTIGATION REPORT

A00W0215

POWER LOSS—MECHANICAL MALFUNCTION

EUROCOPTER AS 350BA C-GATX

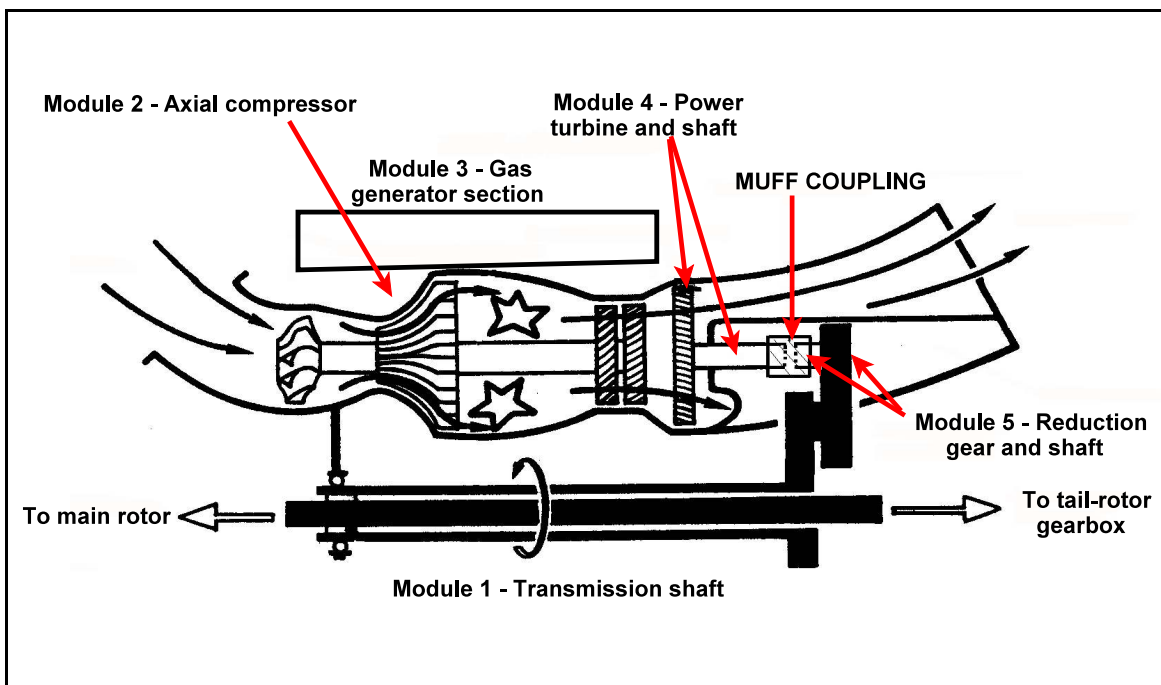
Figure 1 - Engine schematic

The engine is an assembly of five major modules (Figure 1). Modules 2, 3, and 5 had been exchanged with overhauled units from the engine manufacturer about 37 hours before the occurrence. Module 4, the power (free) turbine section, had been in service for about 1200 hours since overhaul.

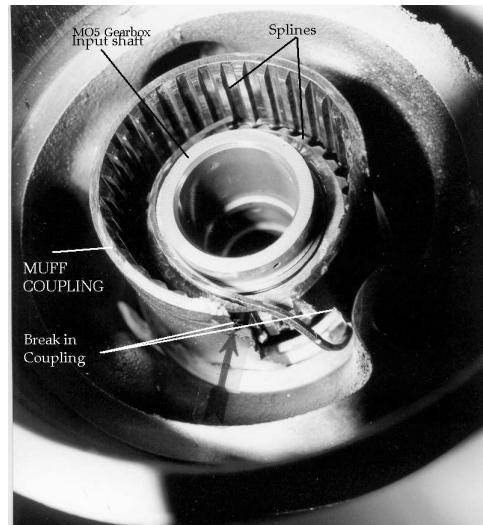
Figure 2 - Muff coupling

It was determined that all the blade root fractures were the result of overload conditions consistent with turbine overspeed. Other rotating components of the engine were undamaged. The muff coupling (part number 029270820) is a splined metal tube that connects and transmits power from the output shaft splined nut of the power turbine section to the input drive pinion splined nut of the reduction gearbox. The muff coupling was found split along its longitudinal

axis. It is a component of the reduction gearbox and was overhauled and inspected about 37 hours before the failure.

Metallurgical examination of the muff coupling at the TSB Engineering Laboratory established that the cause of the failure was the fatigue extension of a crack in the centre section of the coupling. The blocky, intergranular nature of the fracture surface suggests that the crack formed during the quench preceding the nitriding treatment, since a nitride layer was present on the crack surfaces. The manufacturer has advised that the overall nitride layer would mask any existing cracks when checked by magnetic particle inspection (MPI) as the final step of the manufacturing process. The nitride layer would also have resulted in the crack not being detected by MPI during subsequent overhaul inspections since the coupling was placed in service.

Evidence of the nitriding layer through the crack surfaces was an indication that the crack was formed during the manufacturing process, before the final nitriding process and the MPI. Fatigue progression of the crack weakened the coupling until it failed. The nitride layer prevented discovery of the crack by the MPI process.

1. The engine lost power when the muff coupling connecting the power turbine to the reduction gearbox failed.
2. The coupling failed because of the fatigue extension of a crack that originated during the manufacturing process.

- The bar stock (billets) to be manufactured into couplings now undergo magnetic particle inspection (MPI) for any defects when received, before processing.
- The couplings undergo MPI and eddy current inspection after manufacture and heat treatment, but before nitriding.
- The couplings will now be serial numbered from manufacture.

- replace in-service couplings with new ones at overhaul or repair; and
- ensure that replacement couplings, if not serialized from the factory, are etched with the serial number of the reduction gearbox at installation and recorded on the reduction-gearbox log cards.
